Subject: **Revised Armistead Rd. Altered Stand Assessment  
Presidio of San Francisco, CA**

HortScience, Inc. is under contract with Flatiron-Kiewit to help coordinate the tree removal and preservation effort for the P3 portion of the Doyle Dr. construction project. As part of the approval process for removal of trees in the Armistead Rd. area, the Presidio Trust (the Trust) requested that I assess the potential impacts on the trees to remain in the lee of those removed.

**Armistead Altered Stand Trees**  
 Presidio of San Francisco, California  
 May 2013

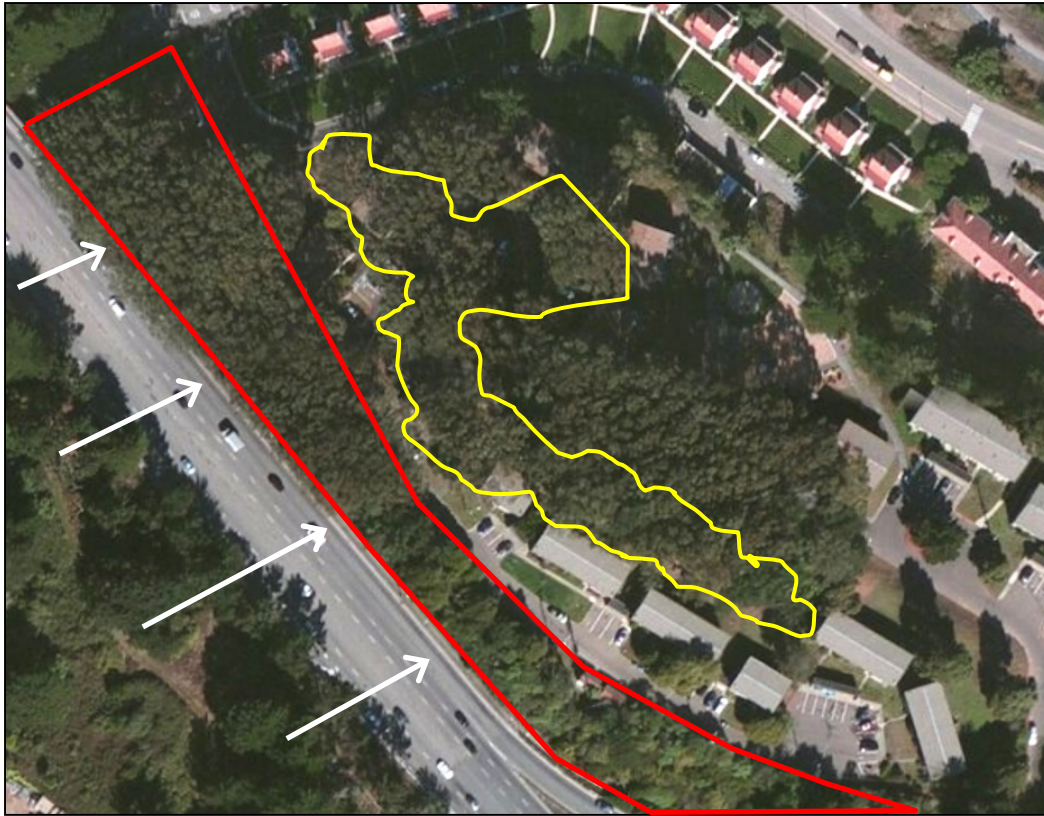
The stand between Armistead and Highway 101 have developed in response to winds coming off the ocean. As a result, trees in the area of Ramsel Ct. (to the north) were protected from the wind by those closer to Hwy. 101. Removal of the trees between Armistead Rd. and Hwy. 101 will remove the leading edge of the forest. Trees on the new edge will be exposed to higher wind velocities than previously, which can result in a greater rate of failure. This is especially true during the first few years, until the trees can acclimate to the new conditions.

**Photo 1:** Aerial image showing the Armistead neighborhood, with dominant wind direction is indicated by arrows. Approximate area of proposed tree removal in the Armistead neighborhood is outlined in red and area of mitigation pruning is outlined in yellow.

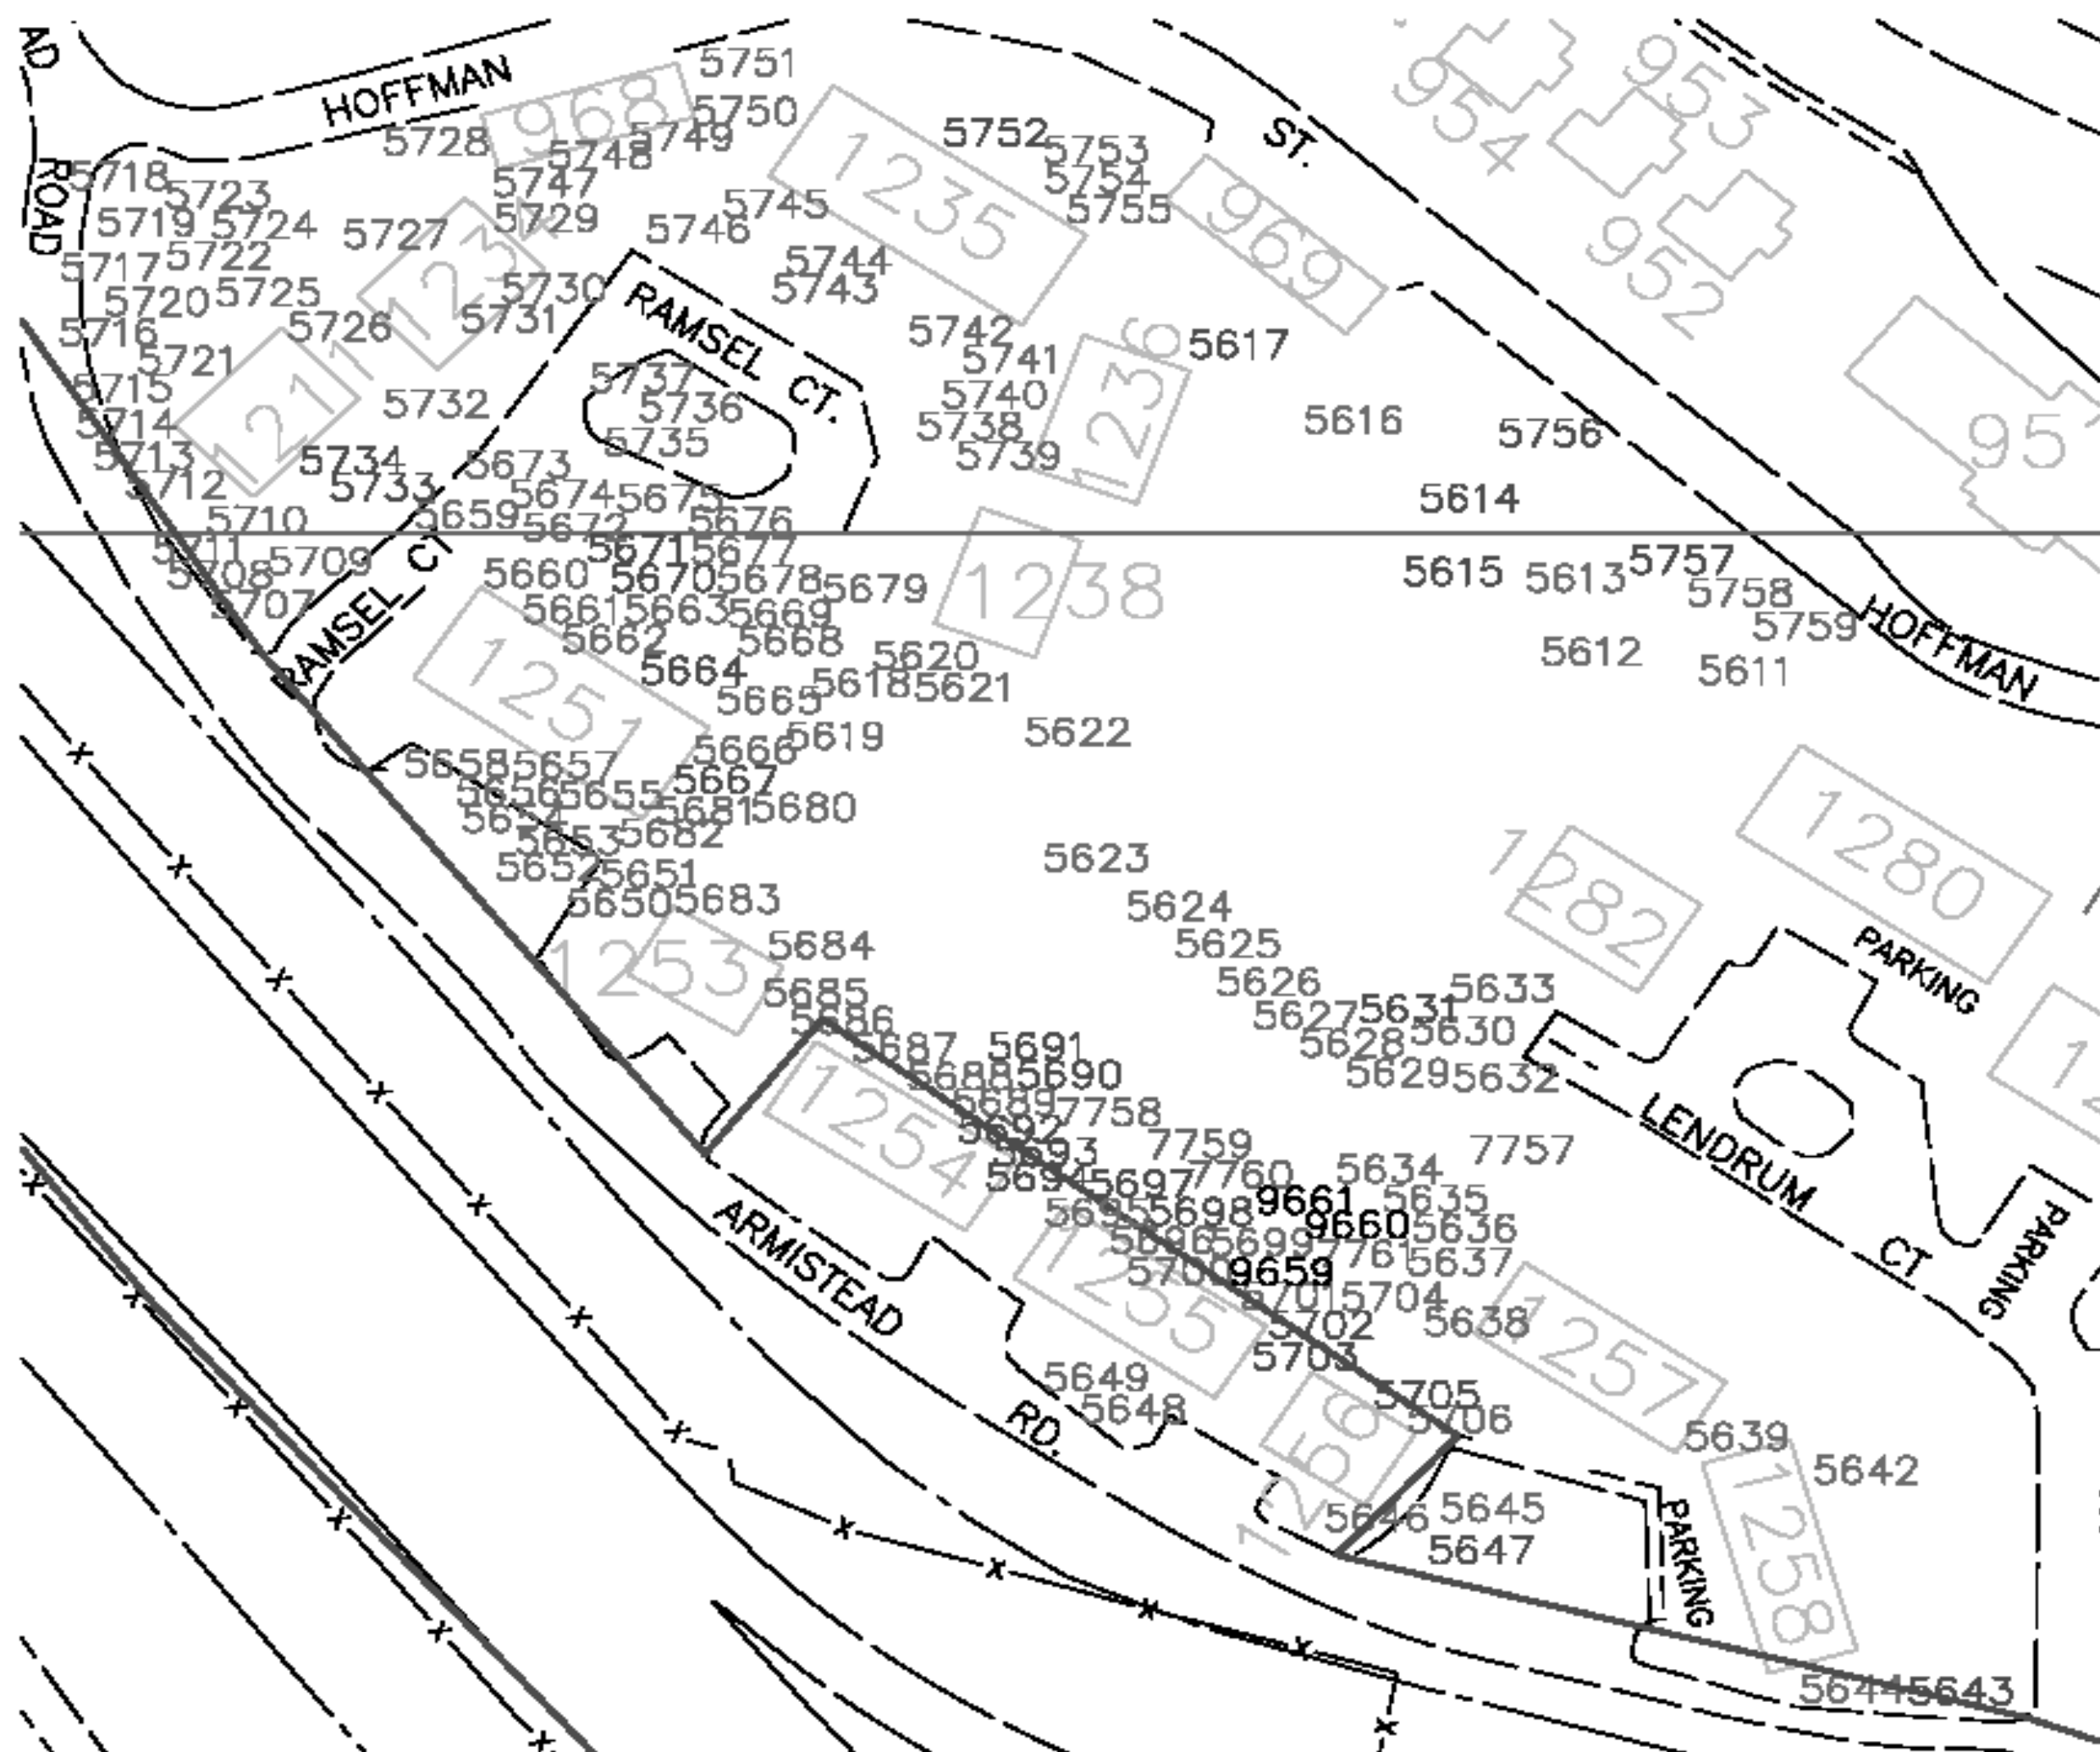
## Tree Assessment Map

I assessed 136 trees between Armistead Rd., Hoffman St. and Lendrum Ct. with the potential to hit a target. Seventy-six (76) of the trees were far enough from the new edge or Ramsel Ct. that no impacts from increased wind speeds are anticipated and no management action was recommended.

Sixty (60) trees were identified as being close enough to either the new edge or Ramsel Ct. to be impacted by the increased wind speeds and require pruning or removal. Following is a brief summary of the recommendations for action. Management recommendations for each tree requiring pruning or removal are provided in Table 1 (following page), as well as in the **Tree Assessment Form** (see Attachments).

- Forty-eight (48) of the trees are recommended for pruning. This group includes 16 trees requiring crown cleaning to remove dead wood greater than 2" in diameter, 36 trees requiring end-weight reduction associated with lateral limbs over the target, and three (3) trees requiring branch removal. Seven (7) of the trees require a combination of crown cleaning and end-weight reduction.
- Twelve (12) trees were identified for removal based on declining health, lean and the presence of decay: #5659, 5669, 5673, 5679, 5709, 5715, 5716, 5722, 5726, 5736, 5737 and 5743.
